**Flood Control Project Maintenance  
Levee Inspections**  
**LMA District Cover Sheet**  
**Spring 2017 Levee Inspection Results**

**Reclamation District No. 0501 Ryer Island**

**Spring 2017 Levee Inspection Results**

**Levee Inspection Report By Mile - Spring 2017**

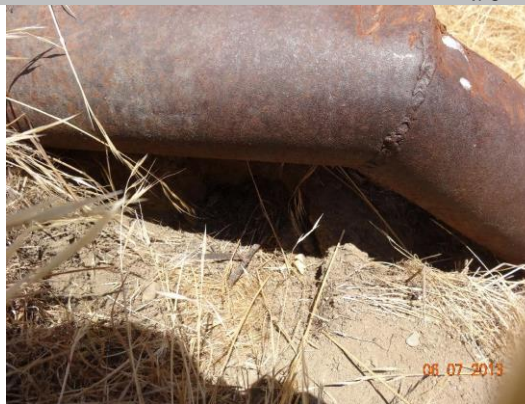
Photo 2 of 3 : UCIP\_SP\_2017\_46768\_30381.jpg

Comment Code					
Inspector Comment					
FS_ID:46768 DS_ID:21049 EP_NO: 1557 Repair Type: Non-Urgent Crossing Status: Found UCIP Comments: Crossing appears abandoned--wooden platform structure appears to be abandoned on waterward side. Small hole underneath pipe on landward side--unable to determine cause (rodent/pipe leak) Need to find owner of crossing to determine status. Recommend removing vegetation along pipe alignment to conduct proper inspection of structure and appurtances. FIELD_STRUCT_DESC: *ABANDONED* 6-inch pipe through the levee, 2.5 feet below the crown. Pump in pump house on waterward slope. (USACE-1959). This entry matches the Drainage or Irrigation Structure referenced in O&M manual (HLM 3.90). Permit No. 1557, 1951). FS Date: 6/7/2013

Burrow activity visible underneath pipe alignment.

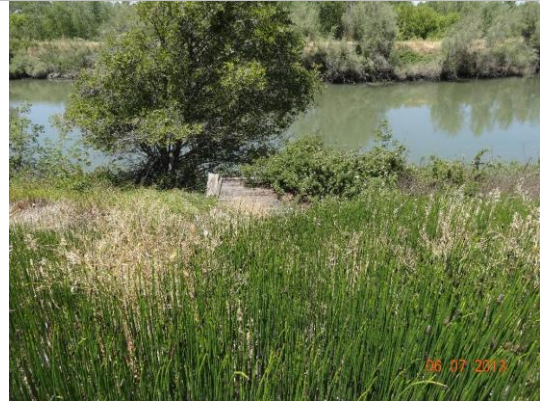
Photo 3 of 3 : UCIP\_SP\_2017\_46768\_30380.jpg

Item	DWR UCIP Field Study			38.267490 °	38.267490 °	
				-121.640749 °	-121.640749 °	
DWR ID						
Comment Code						
Inspector Comment						
FS_ID:46768 DS_ID:21049 EP_NO: 1557 Repair Type: Non-Urgent Crossing Status: Found UCIP Comments: Crossing appears abandoned--wooden platform structure appears to be abandoned on waterward side. Small hole underneath pipe on landward side--unable to determine cause (rodent/pipe leak) Need to find owner of crossing to determine status. Recommend removing vegetation along pipe alignment to conduct proper inspection of structure and appurtenances. FIELD_STRUCT_DESC: *ABANDONED* 6-inch pipe through the levee, 2.5 feet below the crown. Pump in pump house on waterward slope. (USACE-1959). This entry matches the Drainage or Irrigation Structure referenced in O&M manual (HLM 3.90). Permit No. 1557, 1951). FS Date: 6/7/2013

Overview of waterward side with limited access to structure.

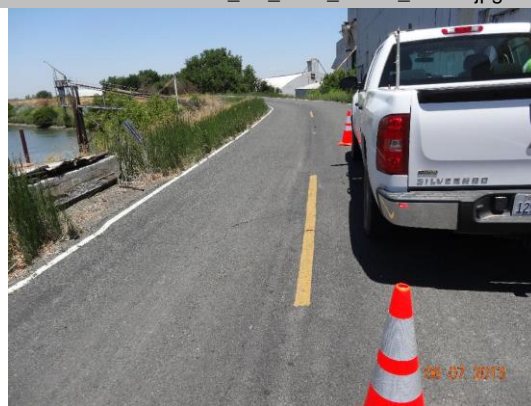
Photo 1 of 3 : UCIP\_SP\_2017\_32540\_59007.jpg

LM Start	3.65	Rating **	M	Issue No.	137
LM End	3.65	Issue Type +	En	Location *	LS
Category	Supplemental			GPS Latitude/Longitude	
				Start	End
Item	DWR UCIP Field Study			38.267818 °	38.267818 °
				-121.640521 °	-121.640521 °
DWR ID					
Comment Code					
Inspector Comment					
FS_ID:32540 DS_ID:21050 EP_NO: N/A Repair Type: Non-Urgent Crossing Status: Found UCIP Comments: Unable to properly inspect structure--limited access. Also unable to determine if structure is still in use. Levee logs indicate this crossing is abandoned. If strcture is no longer used-how to prevent water from flowing through levee during flood season. If structure no longer in use owner will need to coordinate with CVFPB. FIELD_STRUCT_DESC: *ABANDONED* 5.5 x 5.5 foot concrete tunnel through the levee, 6.5 feet below the crown. FS Date: 6/7/2013

View of narrow levee crown.

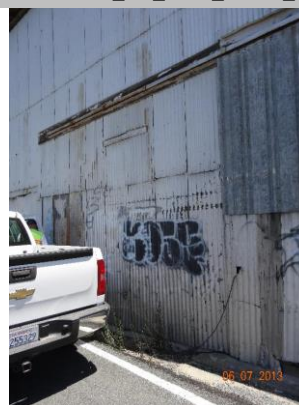
Photo 2 of 3 : UCIP\_SP\_2017\_32540\_59006.jpg

View of large building structure located on landward side.

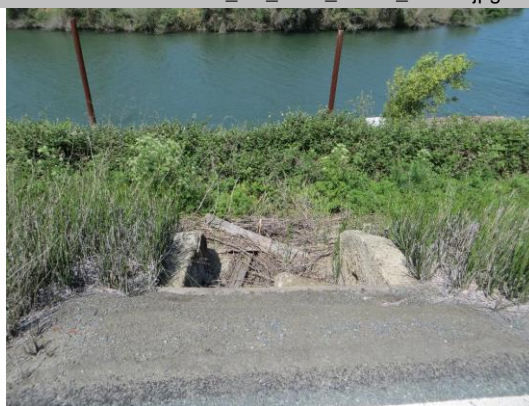
Photo 2 of 3 : UCIP\_SP\_2017\_50023\_73941.jpg

Item	DWR UCIP Field Study			38.268003 °	38.268003 °	
				-121.640474 °	-121.640474 °	
DWR ID						
Comment Code						
Inspector Comment						
FS_ID:50023 DS_ID:21051 EP_NO: N/A Repair Type: Urgent Crossing Status: Found UCIP Comments: 8/22/2016 Unable to locate due to high traffic area and narrow levee crown. Assume condition is same as previous inspection. CVFPB should review this crossing to determine if WS needs to be capped off for flood season. (DWR UCIP - omagana)4/23/2015 Concrete deteriorating. Pipe open on both ends. Appears abandoned and if so should be done so properly. (DWR UCIP - omagana) FIELD_STRUCT_DESC: *ABANDONED* 5.5-foot by 6.0-foot concrete tunnel through the levee, 2.5 feet below the crown. FS Date: 8/22/2016

Concrete tunnel and wingwalls visible on WS slope.

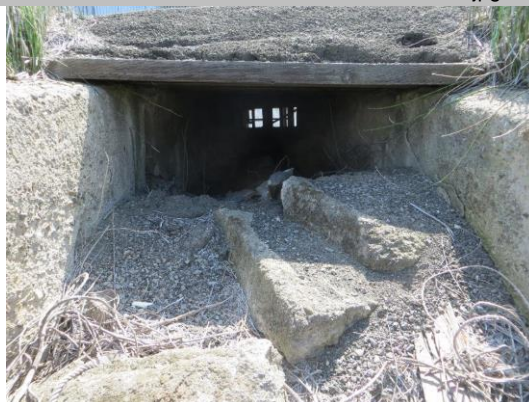
Photo 3 of 3 : UCIP\_SP\_2017\_50023\_73940.jpg

Tunnel open on both ends.

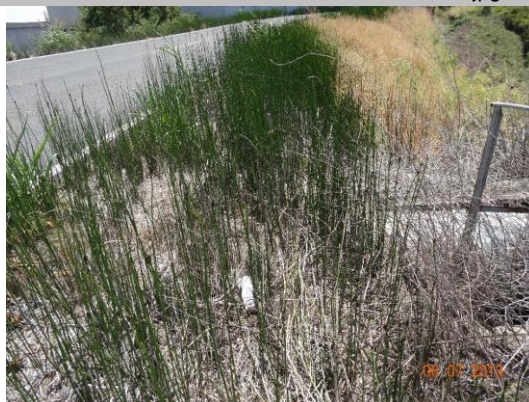
Photo 2 of 3 : UCIP\_SP\_2017\_19662\_33418.jpg

Dense vegetation along the pipe alignment and throughout waterward slope.

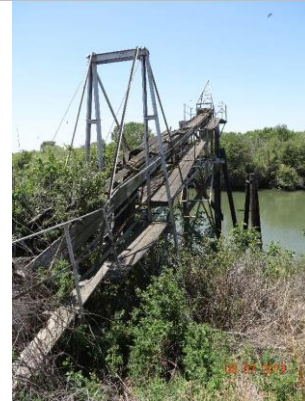
Photo 3 of 3 : UCIP\_SP\_2017\_19662\_33419.jpg

LM Start	3.68	Rating **	M	Issue No.	139 (cont)
LM End	3.68	Issue Type +	En	Location *	LS
Category	Supplemental			GPS Latitude/Longitude	
				Start	End
Item	DWR UCIP Field Study			38.268278 °	38.268278 °
				-121.640377 °	-121.640377 °
DWR ID					
Comment Code					
Inspector Comment					
FS_ID:19662 DS_ID:21052 EP_NO: N/A Repair Type: Non-Urgent Crossing Status: Found UCIP Comments: Need to abandon structure properly--contact owner. Also if crossing is still in use--recommend removing vegetation along pipe alignment to conduct proper inspection of structure and appurtenances. FIELD_STRUCT_DESC: 36-inch pipe through the levee, 5.0 feet below the crown. Grain loading auger sleeved through the pipe. Grain loading system on platform in channel. (Permit No. 1503, 1959). This entry matches the Drainage or Irrigation Structure referenced in O&M manual (HLM 4.00). FS Date: 6/7/2013

Reminiscence of grain loading auger located on waterward slope.

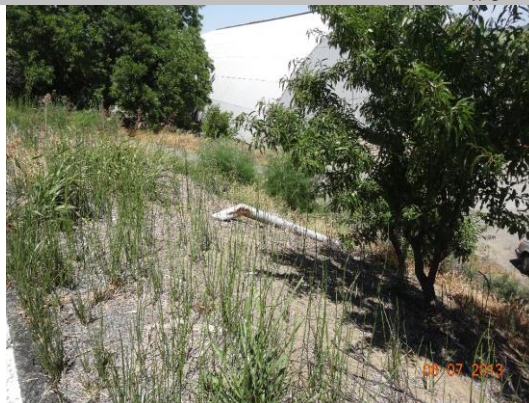
Photo 2 of 3 : UCIP\_SP\_2017\_43524\_33424.jpg

LM Start	3.70	Rating **	M	Issue No.	140 (cont)	
LM End	3.70	Issue Type +	En	Location *	LS	
Category	Supplemental			GPS Latitude/Longitude		
				Start		End
Item	DWR UCIP Field Study			38.268570 °		38.268570 °
				-121.640408 °		-121.640408 °
DWR ID						
Comment Code						
Inspector Comment						
FS_ID:43524 DS_ID:21053 EP_NO: N/A Repair Type: Non-Urgent Crossing Status: Found UCIP Comments: Dense vegetation limits the inspector's visibility to identify signs of pipe failure (leaks) through the waterward slope. Recommend removing vegetation along pipe alignment to conduct proper inspection of structure and appurtenances. FIELD_STRUCT_DESC: 6-inch pipe through the levee, 2.5 feet below the crown. Pump in pump house on waterward slope. (USACE-1959). This entry matches the Drainage or Irrigation Structure referenced in O&M manual (HLM 4.00). (Permit No. 1557, 1951). FS Date: 6/7/2013

View of landward side. Pipe visible.

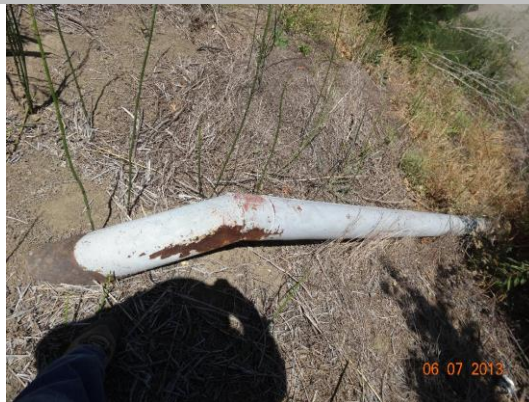
Photo 3 of 3 : UCIP\_SP\_2017\_43524\_33423.jpg

Close up of pipe along landward side.

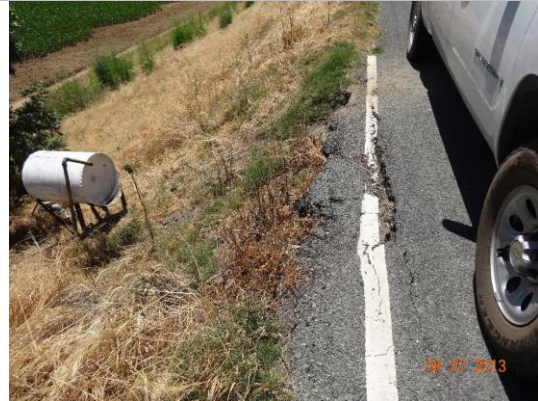
Photo 3 of 3 : UCIP\_SP\_2017\_44876\_33430.jpg

Comment Code					
Inspector Comment					
FS_ID:44876 DS_ID:21069 EP_NO: N/A Repair Type: Non-Urgent Crossing Status: Found UCIP Comments: Damage to levee shoulder. Crossing appears to be still be in use--need to contact owner to inform about maintenance issues. Dense vegetation limits the inspector's visibility to identify signs of pipe failure (leaks) along the waterward and landward slope. Recommend removing vegetation along pipe alignment to conduct proper inspection of structure and appurtenances. FIELD_STRUCT_DESC: 24-inch pipe through the levee, 6.5 feet below the crown. Cutoff wall around pipe at waterward shoulder. Siphon breaker on apex of pipe at landward shoulder. Pump in pump house on landward slope. (USACE-1959). This entry matches the Drainage or Irrigation Structure referenced in O&M manual (HLM 4.60). 18-inch steel pipe sleeved through the 24-inch pipe under Permit No. 2496 (1957). Annular gap grouted. FS Date: 6/7/2013

View of landward side. Dry vegetation covers landward slope. Pump system located on landward slope.

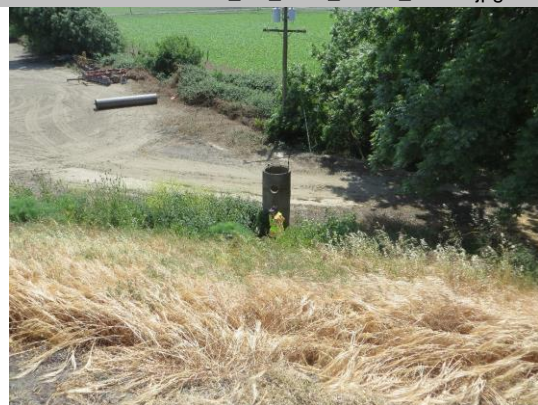
Photo 1 of 2 : UCIP\_SP\_2017\_44746\_73944.jpg

LM Start	4.31	Rating **	M	Issue No.	142
LM End	4.31	Issue Type +	En	Location *	LS
Category	Supplemental			GPS Latitude/Longitude	
				Start	End
Item	DWR UCIP Field Study			38.275955 °	38.275955 °
				-121.638626 °	-121.638626 °
DWR ID					
Comment Code					
Inspector Comment					
FS_ID:44746					
DS_ID:21107					
EP_NO: N/A					
Repair Type: Non-Urgent					
Crossing Status: Indicator Found					
UCIP Comments: Need to verify type of abandonment.					
FIELD_STRUCT_DESC: *ABANDONED* 10-inch pipe through the					
levee, 4.8 feet below the crown. 34-inch concrete standpipe on LS toe.					
10-inch diameter hole in standpipe where abandoned pipe once					
connected (USACE-1959). This entry matches the Drainage or					
Irrigation Structure referenced in O&M manual (HLM 4.60).					
FS Date: 4/23/2015

34-inch diameter concrete standpipe at LS toe.

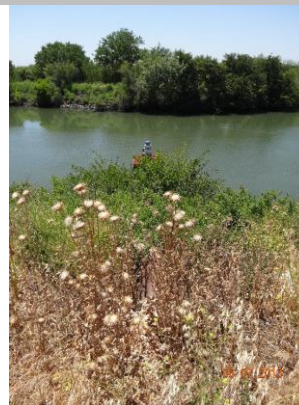
Photo 1 of 2 : UCIP\_SP\_2017\_32541\_59008.jpg

Comment Code					
Inspector Comment					
FS_ID:32541 DS_ID:21071 EP_NO: N/A Repair Type: Non-Urgent Crossing Status: Found UCIP Comments: --Contact owner--Dense vegetation limits the inspector's visibility to identify signs of pipe failure (leaks) along the waterward and landward slopes. Recommend removing vegetation along pipe alignment to conduct proper inspection of structure and appurtances. Walkway and siphon breaker not found. FIELD_STRUCT_DESC: 12-inch concrete pipe through the levee, 2.5 feet below the crown. Cutoff wall around pipe at center of levee. Siphon breaker on apex of pipe at shoulder. Pump on pile structure in stream. Walkway access to pump. (USACE-1959). This entry matches the Drainage or Irrigation Structure referenced in O&M manual (HLM 5.10). FS Date: 6/7/2013

View of waterward side. Pump located on pile structure in stream.

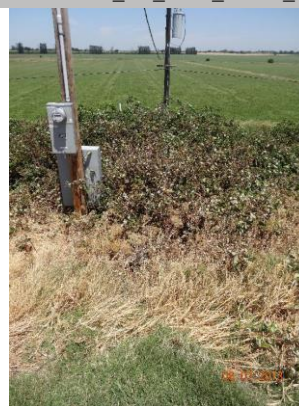
Photo 2 of 2 : UCIP\_SP\_2017\_32541\_59009.jpg

Item	DWR UCIP Field Study			38.281041 °	38.281041 °	
				-121.640904 °	-121.640904 °	
DWR ID						
Comment Code						
Inspector Comment						
FS_ID:32541 DS_ID:21071 EP_NO: N/A Repair Type: Non-Urgent Crossing Status: Found UCIP Comments: --Contact owner--Dense vegetation limits the inspector's visibility to identify signs of pipe failure (leaks) along the waterward and landward slopes. Recommend removing vegetation along pipe alignment to conduct proper inspection of structure and appurtances. Walkway and siphon breaker not found. FIELD_STRUCT_DESC: 12-inch concrete pipe through the levee, 2.5 feet below the crown. Cutoff wall around pipe at center of levee. Siphon breaker on apex of pipe at shoulder. Pump on pile structure in stream. Walkway access to pump. (USACE-1959). This entry matches the Drainage or Irrigation Structure referenced in O&M manual (HLM 5.10). FS Date: 6/7/2013

View of landward side. Power source and control box on landward side.

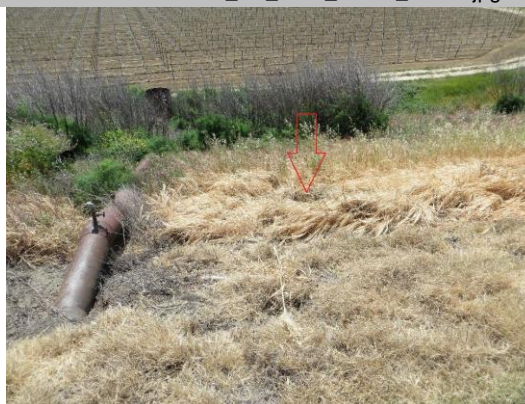
Photo 1 of 2 : UCIP\_SP\_2017\_44877\_73946.jpg

LM Start	5.43	Rating **	M	Issue No.	144
LM End	5.43	Issue Type +	En	Location *	LS
Category	Supplemental			GPS Latitude/Longitude	
				Start	End
Item	DWR UCIP Field Study			38.288951 °	38.288951 °
				-121.644223 °	-121.644223 °
DWR ID					
Comment Code					
Inspector Comment					
FS_ID:44877 DS_ID:21055 EP_NO: N/A Repair Type: Non-Urgent Crossing Status: Found UCIP Comments: Pipe abandoned and should be done so properly. FIELD_STRUCT_DESC: 10-inch steel irrigation pipe through the levee, 1.8-feet below the crown. Pump on pile structure in stream. Pipe exposed on landward side. (USACE-1959). This entry matches the Drainage or Irrigation Structure referenced in O&M manual (HLM 5.90). FS Date: 4/23/2015

Buried pipe exposed in trench 8-feet downstream from visible pipe.

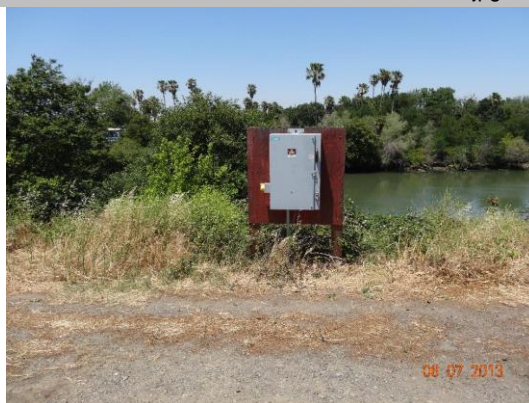
Photo 1 of 3 : UCIP\_SP\_2017\_19666\_33435.jpg

LM Start	5.43	Rating **	M	Issue No.	145
LM End	5.43	Issue Type +	En	Location *	LS
Category	Supplemental			GPS Latitude/Longitude	
				Start	End
Item	DWR UCIP Field Study			38.288950 °	38.288950 °
				-121.644183 °	-121.644183 °
DWR ID					
Comment Code					
Inspector Comment					
FS_ID:19666 DS_ID:21054 EP_NO: N/A Repair Type: Non-Urgent Crossing Status: Found UCIP Comments: Need to find owner and permit number authorizing work. Dense vegetation limits the inspector's visibility to identify signs of pipe failure (leaks) along the waterward and landward slopes. Recommend removing vegetation along pipe alignment to conduct proper inspection of structure and appurtenances. FIELD_STRUCT_DESC: 12-inch pipe through the levee, 3.0 feet below the crown. Pump on pile structure in stream. FS Date: 6/7/2013

Overview of waterward side. Control box located near levee crown.

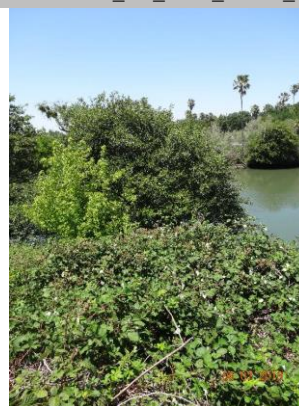
Photo 2 of 3 : UCIP\_SP\_2017\_19666\_33434.jpg

LM Start	5.43	Rating **	M	Issue No.	145 (cont)
LM End	5.43	Issue Type +	En	Location *	LS
Category	Supplemental			GPS Latitude/Longitude	
				Start	End
Item	DWR UCIP Field Study			38.288950 °	38.288950 °
				-121.644183 °	-121.644183 °
DWR ID					
Comment Code					
Inspector Comment					
FS_ID:19666 DS_ID:21054 EP_NO: N/A Repair Type: Non-Urgent Crossing Status: Found UCIP Comments: Need to find owner and permit number authorizing work. Dense vegetation limits the inspector's visibility to identify signs of pipe failure (leaks) along the waterward and landward slopes. Recommend removing vegetation along pipe alignment to conduct proper inspection of structure and appurtenances. FIELD_STRUCT_DESC: 12-inch pipe through the levee, 3.0 feet below the crown. Pump on pile structure in stream. FS Date: 6/7/2013

Structure visible through the dense vegetation. Limited access unable to inspect.

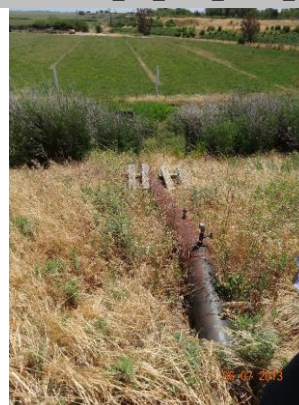
Photo 3 of 3 : UCIP\_SP\_2017\_19666\_33433.jpg

View of pipe on landward side. Dry vegetation covers landward slope.

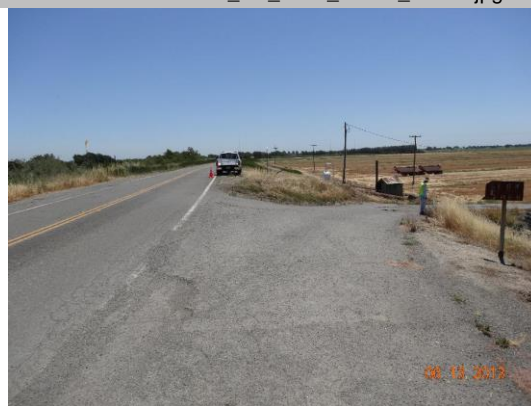
Photo 1 of 3 : UCIP\_SP\_2017\_32542\_59022.jpg

FS\_ID:32542  
DS\_ID:21059  
EP\_NO: N/A  
Repair Type: Non-Urgent  
Crossing Status: Found  
UCIP Comments: Need to determine status of crossing. Horizontal and vertical cracks present on stand pipe located on landward side. Dense vegetation limits the inspector's visibility to identify signs of pipe failure (leaks) along the waterward slope. Recommend removing vegetation along pipe alignment to conduct proper inspection of structure and appurtenances.  
FIELD\_STRUCT\_DESC: 12-inch steel pipe through the levee, 6.0 feet below the crown. 2-inch conduit line through levee. Pump and gate valve on waterward slope. Pipe exposed on landward side. (USACE-1959). This entry matches the Drainage or Irrigation Structure referenced in O&M manual (HLM 6.90).  
FS Date: 6/13/2013

Overview of levee crown at crossing.

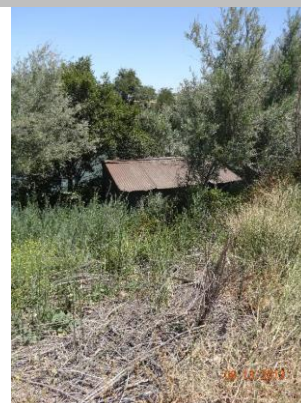
Photo 2 of 3 : UCIP\_SP\_2017\_32542\_59023.jpg

View of waterward side. Dense vegetation along levee slope.

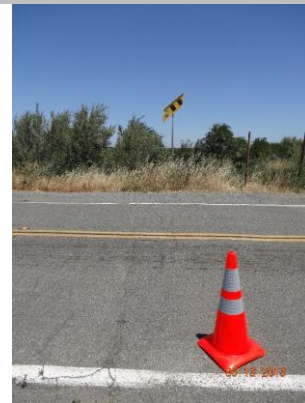
Photo 1 of 3 : UCIP\_SP\_2017\_42118\_72902.jpg

LM Start	6.40	Rating **	M	Issue No.	147
LM End	6.40	Issue Type +	En	Location *	LS
Category	Supplemental			GPS Latitude/Longitude	
				Start	End
Item	DWR UCIP Field Study			38.290356 °	38.290356 °
				-121.627488 °	-121.627488 °
DWR ID					
Comment Code					
Inspector Comment					
FS_ID:42118 DS_ID:24054 EP_NO: N/A Repair Type: Non-Urgent Crossing Status: Indicator Found UCIP Comments: Need to determine encroachment number issued for pipe installation. FIELD_STRUCT_DESC: Gasline through levee at an angle with unknown depth. Markers visible on both sides. FS Date: 6/13/2013

Markers visible on waterward side.

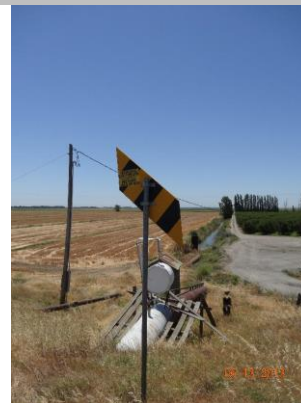
Photo 2 of 3 : UCIP\_SP\_2017\_42118\_72901.jpg

LM Start	6.40	Rating **	M	Issue No.	147 (cont)
LM End	6.40	Issue Type +	En	Location *	LS
Category	Supplemental			GPS Latitude/Longitude	
				Start	End
Item	DWR UCIP Field Study			38.290356°	38.290356°
				-121.627488°	-121.627488°
DWR ID					
Comment Code					
Inspector Comment					
FS_ID:42118 DS_ID:24054 EP_NO: N/A Repair Type: Non-Urgent Crossing Status: Indicator Found UCIP Comments: Need to determine encroachment number issued for pipe installation. FIELD_STRUCT_DESC: Gasline through levee at an angle with unknown depth. Markers visible on both sides. FS Date: 6/13/2013

Marker visible on landward side.

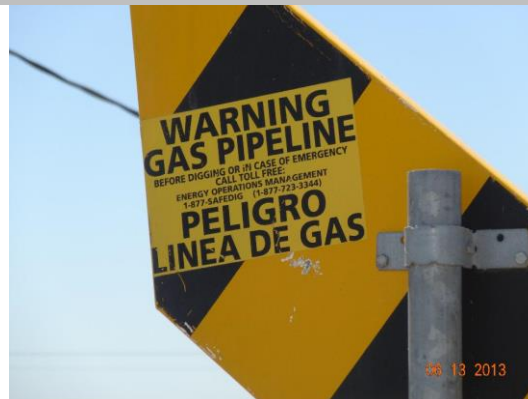
Photo 3 of 3 : UCIP\_SP\_2017\_42118\_72900.jpg

Marker with contact information on landward side.

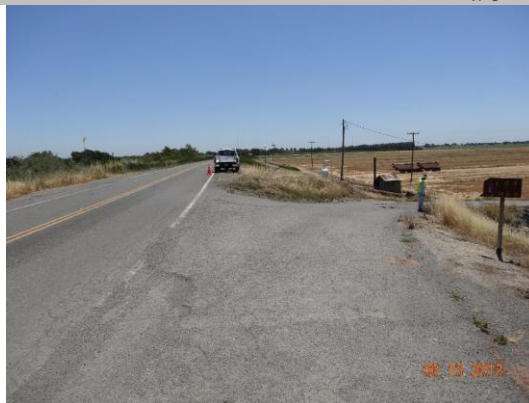
Photo 1 of 3 : UCIP\_SP\_2017\_19668\_33446.jpg

FS\_ID:19668  
DS\_ID:21057  
EP\_NO: N/A  
Repair Type: Non-Urgent  
Crossing Status: Found  
UCIP Comments: Crossing was operating during inspection; Dense vegetation limits the inspector's visibility to identify signs of pipe failure (leaks) along the waterward slope. Recommend removing vegetation along pipe alignment to conduct proper inspection of structure and appurtenances.  
FIELD\_STRUCT\_DESC: 1 of 2: 30-inch steel pipe through the levee, 9.5 feet below the crown. Cutoff wall around pipe at center of levee. Siphon breaker at landward slope. Primer tanks on landward slope. Pipe exposed on both slopes. This entry matches the Drainage or Irrigation Structure referenced in O&M manual (HLM 6.90). Pipe installed under Permit No. 611 in 1934. Section of pipe between shoulders removed and replaced with 30-inch steel pipe under Permit No. 2497 (1959).  
FS Date: 6/13/2013

Overview of levee crown--multiple crossings within a 50 foot stretch.

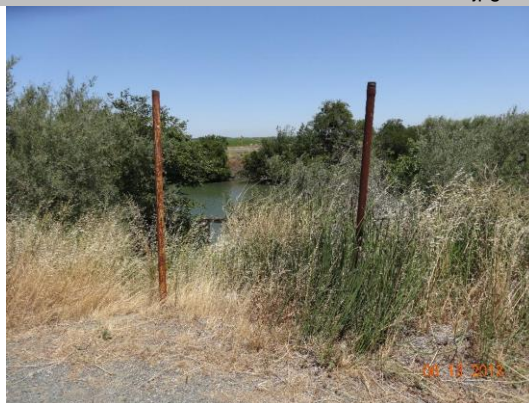
Photo 2 of 3 : UCIP\_SP\_2017\_19668\_33443.jpg

View of waterward side. Metal posts near the levee crown.

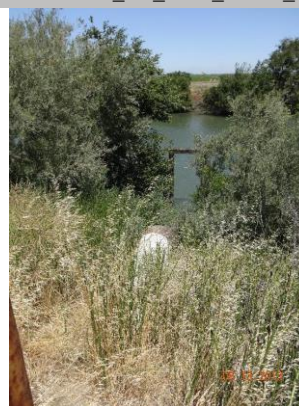
Photo 3 of 3 : UCIP\_SP\_2017\_19668\_33442.jpg

Pipe visible through dense vegetation. Reminiscence of platform located on river.

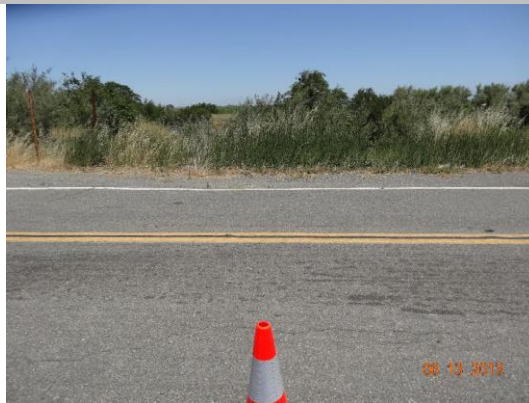
Photo 2 of 3 : UCIP\_SP\_2017\_32543\_59027.jpg

FS\_ID:32543  
DS\_ID:21058  
EP\_NO: N/A  
Repair Type: Non-Urgent  
Crossing Status: Found  
UCIP Comments: Dense vegetation limits the inspector's visibility to identify signs of pipe failure (leaks) along the waterward slope. Recommend removing vegetation along pipe alignment to conduct proper inspection of structure and appurtenances. Need to find pipe owner. Unable to determine status of crossing.  
FIELD\_STRUCT\_DESC: Abandoned 8-inch steel pipe through the levee, 2.7 feet below the crown. Siphon breaker on apex of pipe at landward shoulder. Surge chamber at landward toe. Pump near waterward toe. Pipe exposed on landward side. (USACE-1959). Concrete platform 4 feet by 3 feet located on landward toe. 3-inch conduit runs along 8-inch steel pipe. This entry matches the Drainage or Irrigation Structure referenced in O&M manual (HLM 6.90).  
FS Date: 6/13/2013

View levee crown at crossing.

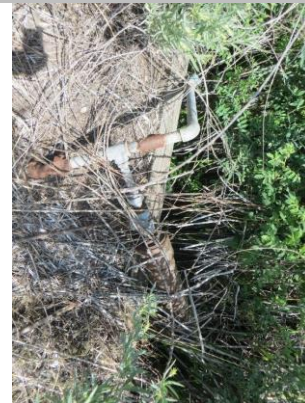
Photo 1 of 2 : UCIP\_SP\_2017\_44748\_73948.jpg

LM Start	6.41	Rating **	M	Issue No.	150
LM End	6.41	Issue Type +	En	Location *	LS
Category	Supplemental			GPS Latitude/Longitude	
				Start	End
Item	DWR UCIP Field Study			38.290356 °	38.290356 °
				-121.627349 °	-121.627349 °
DWR ID					
Comment Code					
Inspector Comment					
FS_ID:44748					
DS_ID:21027					
EP_NO: N/A					
Repair Type: Non-Urgent					
Crossing Status: Found					
UCIP Comments: Pipe appears abandoned and if so should be done so properly.					
FIELD_STRUCT_DESC: 2 of 2: 4-inch steel pipe through the levee, 7.3 feet below the crown. (USACE-1959). Pipe visible on upstream side of wooden platform of WS slope. This entry matches the Drainage or Irrigation Structure referenced in O&M manual (HLM 6.90).					
FS Date: 4/23/2015

4-inch pipe connected to smaller galvanized iron pipe on WS slope.

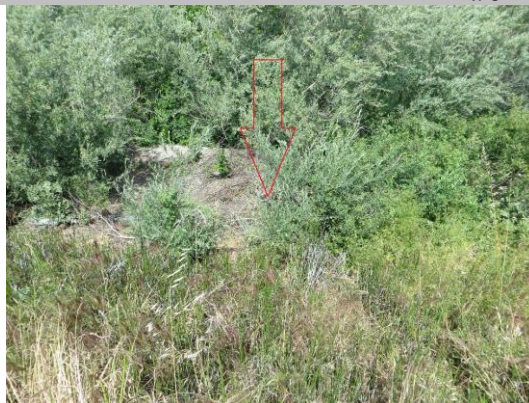
Photo 2 of 2 : UCIP\_SP\_2017\_44748\_73947.jpg

Pipe visible on upstream side of wooden platform on the WS slope.

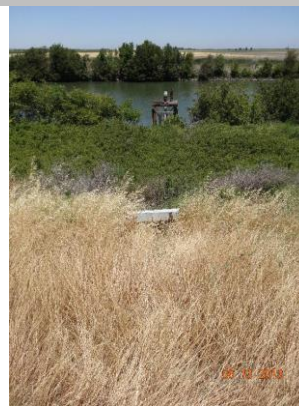
Photo 1 of 3 : UCIP\_SP\_2017\_32544\_59034.jpg

Comment Code					
Inspector Comment					
FS_ID:32544 DS_ID:21060 EP_NO: N/A Repair Type: Non-Urgent Crossing Status: Found UCIP Comments: Dense vegetation limits the inspector's visibility to identify signs of pipe failure (leaks) along the slope. Recommend removing vegetation along pipe alignment to conduct proper inspection of structure and appurtenances. Walkway missing but platform remain on the waterward side. FIELD_STRUCT_DESC: 12-inch pipe through the levee, 6.5 feet below the crown. Switch panel on waterward slope. Pump on pile structure in stream. (USACE-1959). This entry matches the Drainage or Irrigation Structure referenced in O&M manual (HLM 7.30). FS Date: 6/13/2013

View of waterward side. Support piles, conduit line, and pump visible on waterward side. Dense vegetation covers waterward slope.

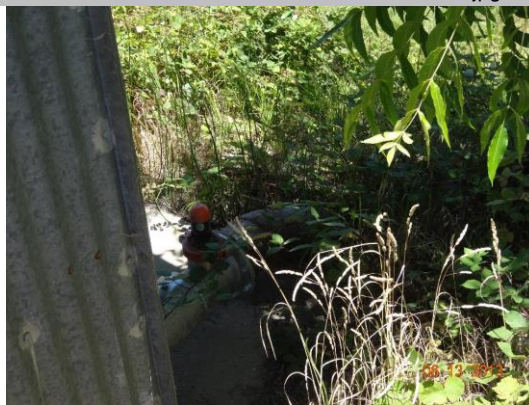
Photo 2 of 3 : UCIP\_SP\_2017\_46834\_33468.jpg

Pipe connection after pump station.

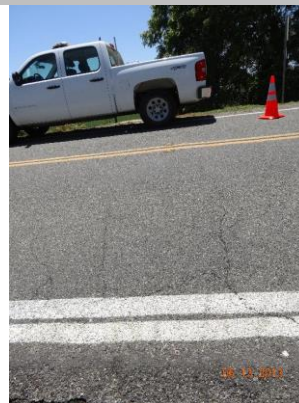
Photo 1 of 3 : UCIP\_SP\_2017\_50025\_59039.jpg

Comment Code					
Inspector Comment					
FS_ID:50025 DS_ID:21063 EP_NO: 11812 Repair Type: Non-Urgent Crossing Status: Found UCIP Comments: 8/22/2016 Crossing has been downgraded from Urgent to Non-Urgent no levee damage appears to be present along pipe alignment. There appears to be an erosion site adjacent to this crossing. Need to coordinate with DWR Inspectors. (DWR UCIP - omagana)6/07/2013 Open cut section of levee on LS slope 8 foot wide--repair work needed. Abandoned pump on waterward berm. Dense vegetation--Recommend removing vegetation along pipe alignment to conduct proper inspection of structure and appurtenances on waterward side. (DWR UCIP - omagana) FIELD_STRUCT_DESC: 14-inch steel pipe and 1.25-inch electrical conduit through the levee, both 3.0 feet below the crown. Cutoff wall around pipe and conduit at center of levee. Siphon breaker on apex of pipe at landward shoulder. Slant pump on waterward slope. Discharge structure at landward toe. Rock revetment on waterward slope. (Permit No. 11812-1976) FS Date: 8/22/2016

View of levee crown at crossing.

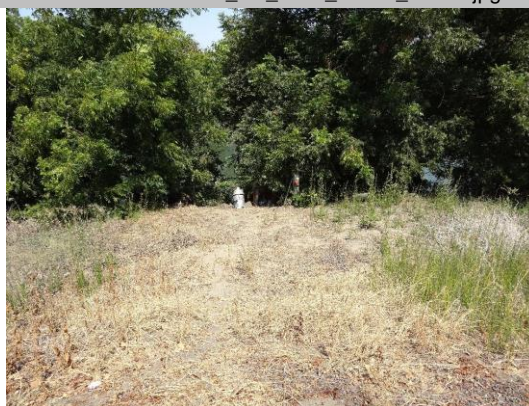
Photo 3 of 3 : UCIP\_SP\_2017\_50025\_75668.jpg

View of WS.

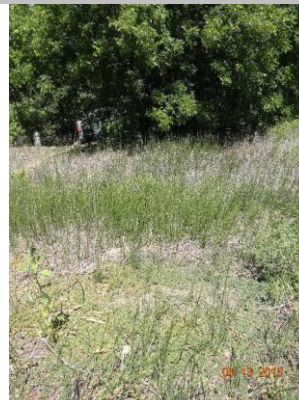
Photo 2 of 3 : UCIP\_SP\_2017\_32546\_59048.jpg

View of waterward side--dense vegetation limits visibility of 8-inch steel pipe. Pump belongs to another crossing.

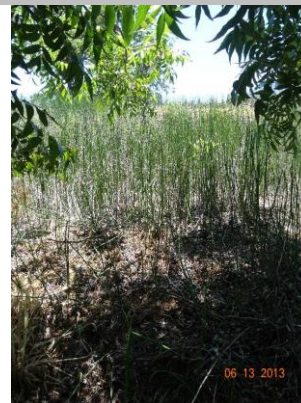
Photo 3 of 3 : UCIP\_SP\_2017\_32546\_59049.jpg

View of waterward side looking up at levee shoulder.

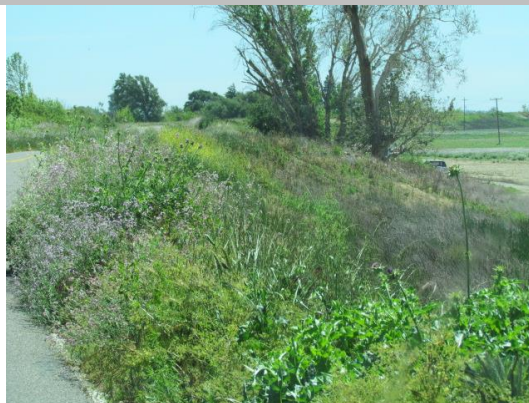
Photo 1 of 1 : SP\_2017\_RD0501\_172\_11\_20170522\_00029.jpg

LM Start	0.04	Rating **	U	Issue No.	11
LM End	1.11	Issue Type +	Ma	Location *	LS
Category	Earthen Levee			GPS Latitude/Longitude	
				Start	End
Item	Vegetation			38.284987 °	38.270940 °
				-121.605500 °	-121.604490 °
DWR ID	DWR_RD0501_04_s_2017_11				
Comment Code					
V1 : Control annual grass and weeds on the levee slopes and easements.					
Inspector Comment					
Control the annual grasses and weeds on the levee shoulder and slope.

RD 501 Unit 4 levee mile 0.04 landside slope and shoulder.

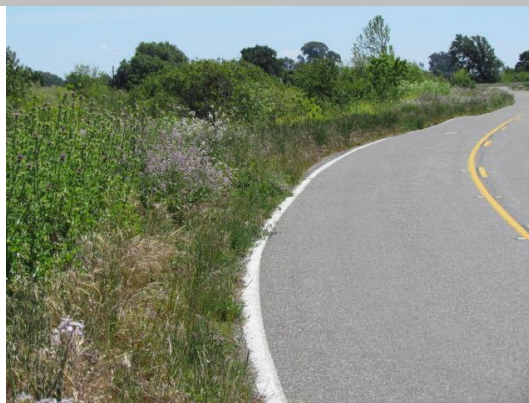
Photo 1 of 1 : SP\_2017\_RD0501\_172\_12\_20170522\_00030.jpg

LM Start	0.04	Rating **	U	Issue No.	12
LM End	2.28	Issue Type +	Ma	Location *	WS
Category	Earthen Levee			GPS Latitude/Longitude	
				Start	End
Item	Vegetation			38.284987 °	38.254465 °
				-121.605500 °	-121.601450 °
DWR ID	DWR_RD0501_04_s_2017_12				
Comment Code					
V1 : Control annual grass and weeds on the levee slopes and easements.					
Inspector Comment					
Control the annual grasses and weeds from the shoulder and slope water ward.

RD 501 Unit 4 levee mile 0.04 to levee mile 2.28 waterside shoulder and slope.

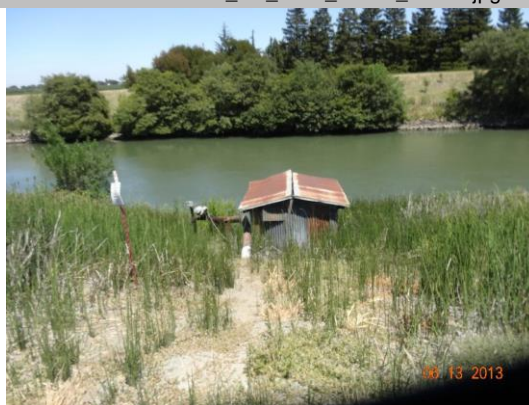
Photo 2 of 3 : UCIP\_SP\_2017\_32547\_59051.jpg

Overview of waterward side--2 crossings located within 5 feet.

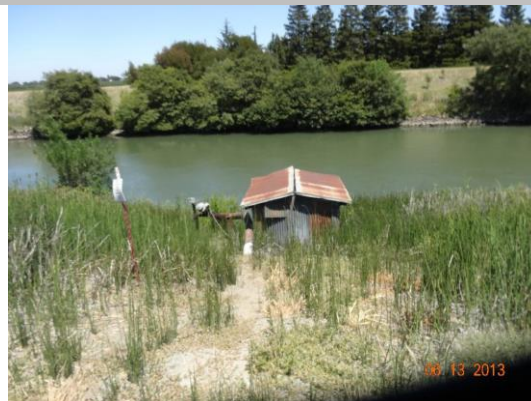
Photo 2 of 3 : UCIP\_SP\_2017\_32548\_59058.jpg

FS\_ID:32548  
DS\_ID:21079  
EP\_NO: 2446  
Repair Type: Non-Urgent  
Crossing Status: Found  
UCIP Comments: Permit documents indicate that pipe does not appear to be properly grouted. Crossing needs to be properly abandoned per CVFPB Title 23--need to find owner. Also recommend removing vegetation along pipe alignment to conduct proper inspection of structure and appurtenances.  
FIELD\_STRUCT\_DESC: \*ABANDONED\* 8-inch steel pipe through the levee, 6.0 feet below the crown. Pump on waterward side. Steel plate welded on waterward end. (USACE-1959). This entry matches the Drainage or Irrigation Structure referenced in O&M manual (HLM 0.60). Pipe was abandoned under Permit No. 2446 (1957). 10-inch steel pipe is located approximately 5 feet downstream.  
FS Date: 6/13/2013

Overview of waterward side. Two crossings, 10 inch and 8 inch pipelines, less than 5 feet apart.

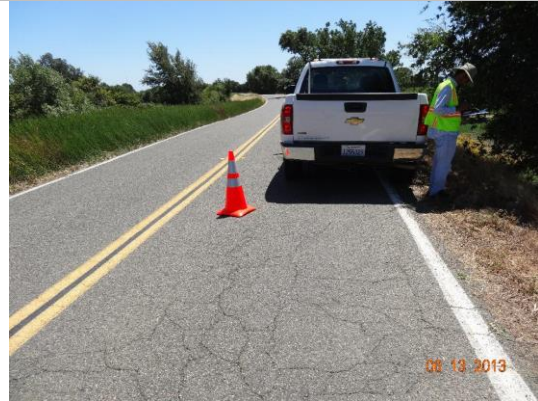
Photo 1 of 3 : UCIP\_SP\_2017\_50021\_59065.jpg

Comment Code					
Inspector Comment					
FS_ID:50021 DS_ID:21072 EP_NO: N/A Repair Type: Urgent Crossing Status: Found UCIP Comments: 8/22/2016 Assume conditions at this crossing have remained the same--pipe wall is still deteriorating. Unable to locate crossing due to dense vegetation along both WS and LS slopes. Recommend removing vegetation along pipe alignment to conduct proper inspection of structure and appurtenances. (DWR UCIP - omagana)6/13/2013 Pipe has deteriorated--holes present on landward side. Need to contact owner. Unable to determine if crossing is still being used. Dense vegetation limits the inspector's visibility to identify signs of pipe failure (leaks) along the waterward slope. Recommend removing vegetation along pipe alignment to conduct proper inspection of structure and appurtenances. (DWR UCIP - omagana) FIELD_STRUCT_DESC: *ABANDONED* 8-inch irrigation steel pipe through the levee, 2.7 feet below the crown. Pump is located on waterside (WS). Steel plate welded on WS end unable to confirm if plate is still present 2016. [Additional Reference(s): DWR Levee Log, 2005. USACE Sacramento O&M Manual Unit No. 105, April 1959, (HLM 1.10)]. FS Date: 8/22/2016

View of levee crown at crossing.

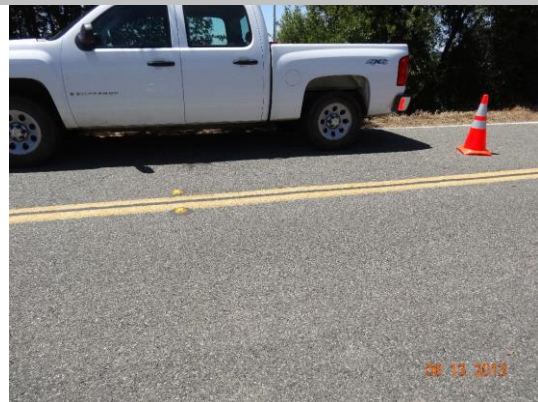
Photo 2 of 3 : UCIP\_SP\_2017\_50021\_59066.jpg

View of levee crown at crossing.

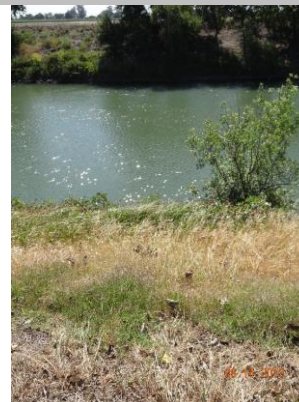
Photo 2 of 3 : UCIP\_SP\_2017\_32550\_59067.jpg

LM Start	1.08	Rating **	M	Issue No.	21
LM End	1.08	Issue Type +	En	Location *	WS
Category	Supplemental			GPS Latitude/Longitude	
				Start	End
Item	DWR UCIP Field Study			38.271400 °	38.271400 °
				-121.604368 °	-121.604368 °
DWR ID					
Comment Code					
Inspector Comment					
FS_ID:32550 DS_ID:21073 EP_NO: N/A Repair Type: Non-Urgent Crossing Status: Indicator Found UCIP Comments: Unable to determine if the pipe goes through the levee. need As-Built drawings; Need owner information. FIELD_STRUCT_DESC: 1.5-inch conduit through the levee, 2.0 feet below the crown. Pole and anchor on landward slope. FS Date: 6/13/2013

View of waterward side.

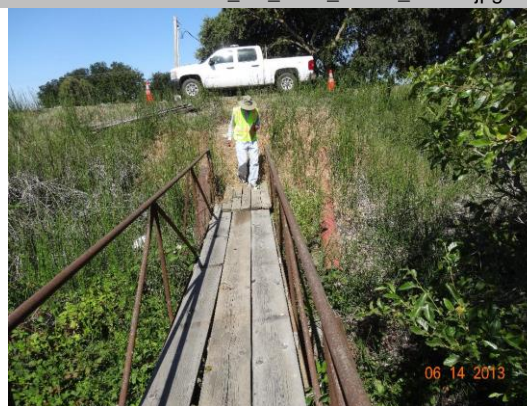
Photo 2 of 3 : UCIP\_SP\_2017\_32551\_59072.jpg

Comment Code						
Inspector Comment						
FS_ID:32551 DS_ID:21074 EP_NO: N/A Repair Type: Non-Urgent Crossing Status: Found UCIP Comments: Unable to determine status of crossing. Pipe visible on waterward side--could be the pipe that was supposed to be removed under permit number 13983 (1985). Also present is a 1.5 inch conduit along the 8 inch pipe. Need to coordinate with owner. FIELD_STRUCT_DESC: 8-inch steel pipe through the levee, 6.4 feet below the crown. Pump on pile structure in stream. Service pole on landward slope. (USACE-1959). This entry matches the Drainage or Irrigation Structure referenced in O&M manual (HLM 1.30). Pipe should have been removed and replaced with 12-inch pipe under Permit No. 13983 (1985). FS Date: 6/13/2013

Abandoned pipe to the right of walkway.

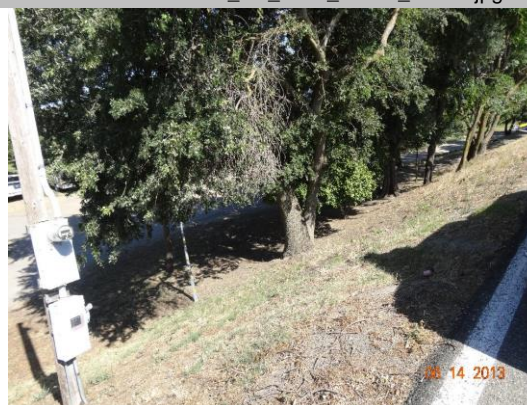
Photo 3 of 3 : UCIP\_SP\_2017\_32551\_59071.jpg

View of landward side--power pole on slope.

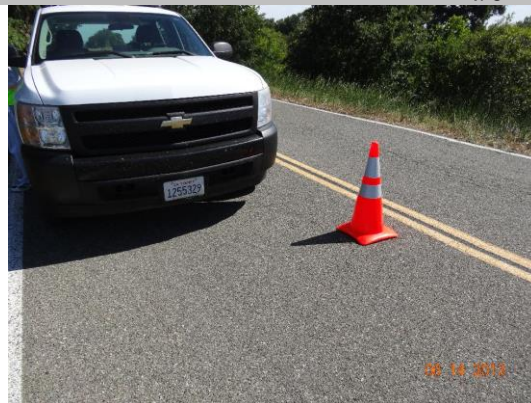
Photo 1 of 3 : UCIP\_SP\_2017\_32552\_59073.jpg

Comment Code					
Inspector Comment					
FS_ID:32552 DS_ID:21095 EP_NO: 13983 Repair Type: Non-Urgent Crossing Status: Found UCIP Comments: Abandoned pipe was to be removed during the installation of new 12-inch pipe crossing. Need to contact pipe owner. Unable to confirm crossing--need additional records for crossing. FIELD_STRUCT_DESC: 12-inch steel pipe through the levee, 5.0 feet below the crown. Cutoff wall around pipe at center of levee. Siphon breaker on apex of pipe at landward shoulder. Pump on pile structure in stream. Service pole on landward slope. Pipe connects to 10-inch steel pipe along the landward slope at the shoulder, and similarly to pre-existing 8-inch pipe on the watereward side. (Permit No. 13983-1985) FS Date: 6/13/2013

View of levee crown at crossing.

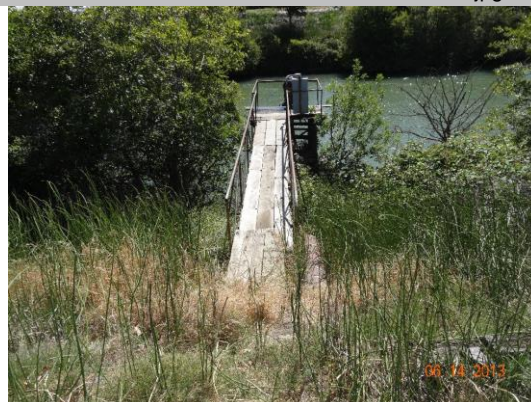
Photo 2 of 3 : UCIP\_SP\_2017\_32552\_59076.jpg

View of waterward side--walkway, pump, conduit, and pipe.

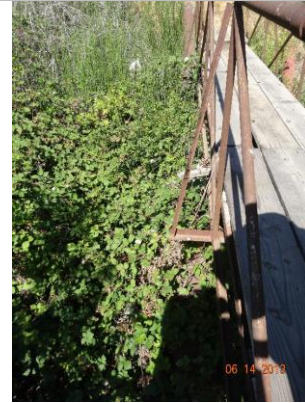
Photo 3 of 3 : UCIP\_SP\_2017\_32552\_59075.jpg

Comment Code						
Inspector Comment						
FS_ID:32552						
DS_ID:21095						
EP_NO: 13983						
Repair Type: Non-Urgent						
Crossing Status: Found						
UCIP Comments: Abandoned pipe was to be removed during the installation of new 12-inch pipe crossing. Need to contact pipe owner. Unable to confirm crossing--need additional records for crossing.						
FIELD_STRUCT_DESC: 12-inch steel pipe through the levee, 5.0 feet below the crown. Cutoff wall around pipe at center of levee. Siphon breaker on apex of pipe at landward shoulder. Pump on pile structure in stream. Service pole on landward slope. Pipe connects to 10-inch steel pipe along the landward slope at the shoulder, and similarly to pre-existing 8-inch pipe on the waterward side. (Permit No. 13983-1985)						
FS Date: 6/13/2013

Pipe suspended on waterward side along walkway.

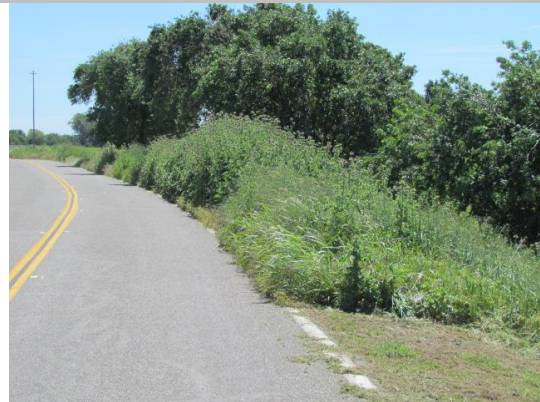
Photo 1 of 1 : SP\_2017\_RD0501\_172\_14\_20170522\_00031.jpg

LM Start	1.21	Rating **	U	Issue No.	14
LM End	2.17	Issue Type +	Ma	Location *	LS
Category	Earthen Levee			GPS Latitude/Longitude	
				Start	End
Item	Vegetation			38.269502 °	38.255987 °
				-121.604328 °	-121.600993 °
DWR ID	DWR_RD0501_04_s_2017_14				
Comment Code					
V1 : Control annual grass and weeds on the levee slopes and easements.					
Inspector Comment					
Control the annual grasses and weeds from levee mile 1.21 to levee mile 2.17.

RD 501 Unit 4 levee mile 1.21 to 2.17 landside shoulder and slope.

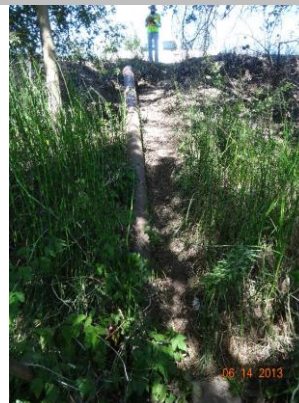
Photo 3 of 3 : UCIP\_SP\_2017\_44471\_33496.jpg

Comment Code						
Inspector Comment						
FS_ID:44471						
DS_ID:21076						
EP_NO: 16906						
Repair Type: Non-Urgent						
Crossing Status: Found						
UCIP Comments: Crossing was running during site inspection. Dense vegetation limits the inspector's visibility to identify signs of pipe failure (leaks) along the landward slope. Recommend removing vegetation along pipe alignment to conduct proper inspection of structure and appurtenances.						
FIELD_STRUCT_DESC: 14-inch steel pipe through the levee, 2.2 feet below the crown. Pump on pile structure in stream. Concrete standpipe on landward side. Pipe is exposed on landward slope. (Permit No. 16906-1999) Two conduits present 3 inch conduit disconnected and 1.5 inch electrical conduit appears to be active.						
FS Date: 6/13/2013

Overview of waterward side.

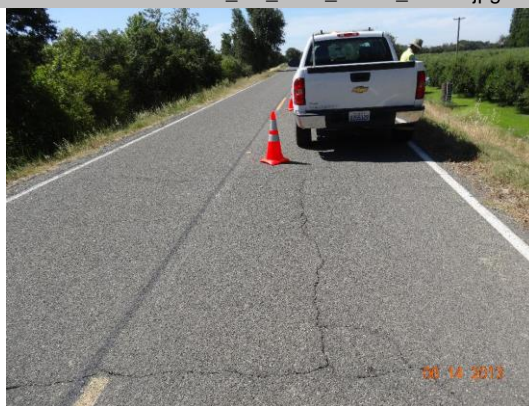
Photo 1 of 3 : UCIP\_SP\_2017\_32553\_59082.jpg

Comment Code					
Inspector Comment					
FS_ID:32553					
DS_ID:21077					
EP_NO: N/A					
Repair Type: Non-Urgent					
Crossing Status: Found					
UCIP Comments: Dense vegetation limits the inspector's visibility to identify signs of pipe failure (leaks) along the waterward and landward slope. Recommend removing vegetation along pipe alignment to conduct proper inspection of structure and appurtenances.					
FIELD_STRUCT_DESC: 14-inch steel pipe through the levee, 8.0 feet below the crown. 2 inch conduit goes through levee. Siphon breaker on landward slope. Pump on pile structure in stream. (USACE-1959). This entry matches the Drainage or Irrigation Structure referenced in O&M manual (HLM 2.0).					
FS Date: 6/13/2013

View of levee crown at crossing.

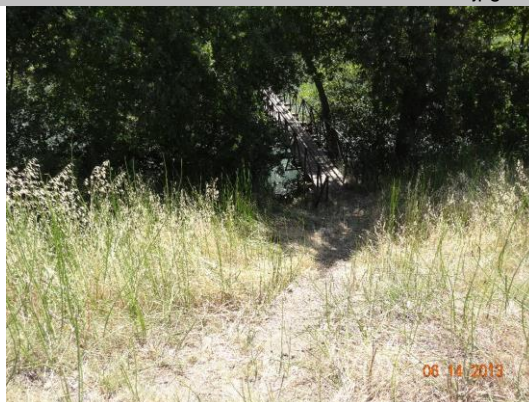
Photo 2 of 3 : UCIP\_SP\_2017\_32553\_59081.jpg

View of waterward side.

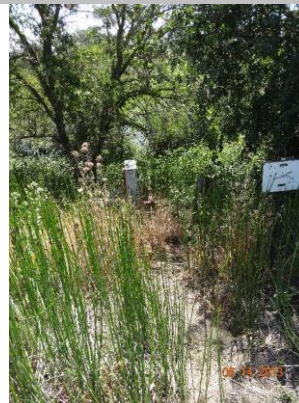
Photo 2 of 3 : UCIP\_SP\_2017\_32863\_59484.jpg

Comment Code					
Inspector Comment					
FS_ID:32863 DS_ID:21078 EP_NO: N/A Repair Type: Non-Urgent Crossing Status: Found UCIP Comments: Broken concrete box on landward slope. Disturbed soil on waterward slope--unable to determine section disturbed. Dense vegetation limits the inspector's visibility to identify signs of pipe failure (leaks) along the waterwar slope. Recommend removing vegetation along pipe alignment to conduct proper inspection of structure and appurtenances. FIELD_STRUCT_DESC: *ABANDONED* 6-inch and working 6-inch steel pipes through the levee, 2.5 and 5.0 feet below the crown, respectively. 1.5 inch electrical conduit through levee. Pump in pump house on waterward slope. (USACE-1959). This entry matches the Drainage or Irrigation Structure referenced in O&M manual (HLM 2.30). Pipes are within 5 feet. FS Date: 6/13/2013

View of waterward side with dense vegetation along slope.

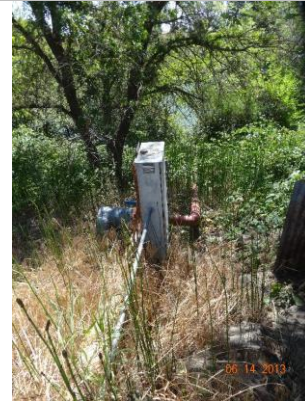
Photo 3 of 3 : UCIP\_SP\_2017\_32863\_59480.jpg

Comment Code					
Inspector Comment					
FS_ID:32863 DS_ID:21078 EP_NO: N/A Repair Type: Non-Urgent Crossing Status: Found UCIP Comments: Broken concrete box on landward slope. Disturbed soil on waterward slope--unable to determine section disturbed. Dense vegetation limits the inspector's visibility to identify signs of pipe failure (leaks) along the waterwar slope. Recommend removing vegetation along pipe alignment to conduct proper inspection of structure and appurtenances. FIELD_STRUCT_DESC: *ABANDONED* 6-inch and working 6-inch steel pipes through the levee, 2.5 and 5.0 feet below the crown, respectively. 1.5 inch electrical conduit through levee. Pump in pump house on waterward slope. (USACE-1959). This entry matches the Drainage or Irrigation Structure referenced in O&M manual (HLM 2.30). Pipes are within 5 feet. FS Date: 6/13/2013

View of waterward side--conduit, pump, control panel, and pipe. Soil piled on right corner of photo--excavation?
